SUCCESS STORY

SINEWAVE NEXUS™

MOTOR PROTECTION FILTERS

SineWave Nexus™ Significantly Reduces Downtime and Increases Life of Conveyor Gearboxes and Motors for Global Courier Company

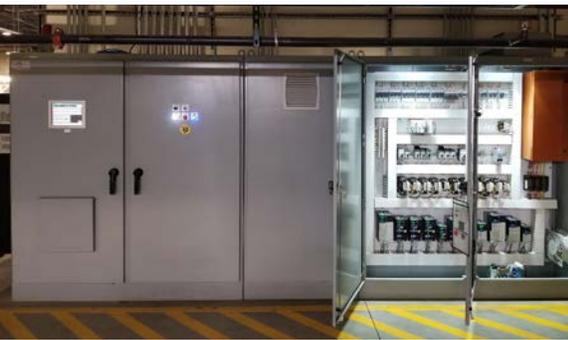
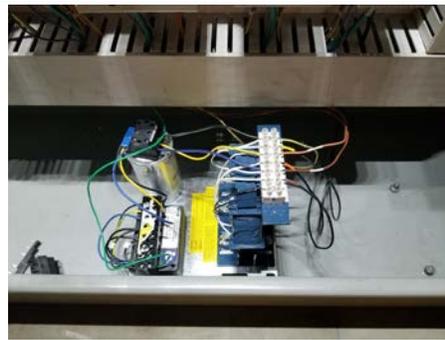
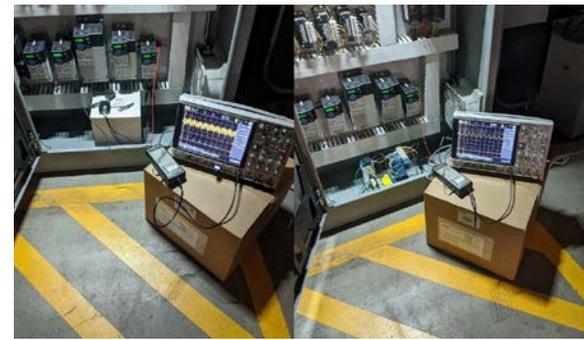
Differential Mode Voltage with Frequency Spectrum

SineWave Nexus™ Performance:

High peak voltages when no filter is present results in the degrading of motor winding insulation and cable insulation.

With the SineWave Nexus installed, the damaging effects from peak voltages, fast rise times, and reflected wave were greatly reduced. The common mode voltage and current, that caused significant bearing degradation, were virtually eliminated. Overall, the installation of the SineWave Nexus has led to the following:

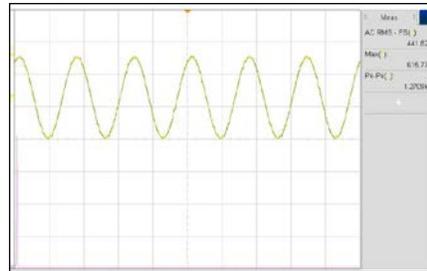
With SineWave Nexus

With the Nexus installed, peak voltages are reduced by nearly 50%, thus extending the life of the insulation.

Differential Mode Voltage (phase to phase)	Pre Nexus Installation	Post Nexus Installation	Percent Reduction
Peak	1,161V	615.8V	46.9%
RMS	539.1V	441.8V	18%

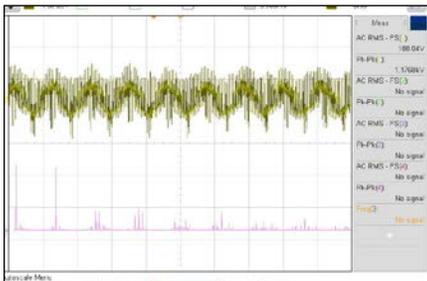
Without SineWave Nexus

Common Mode Voltage with Frequency Spectrum

Common Mode Voltage (neutral to ground)	Pre Nexus Installation	Post Nexus Installation	Percent Reduction
Peak	588V	9.0V	98.5%
RMS	23.9V	6.4V	73.2%

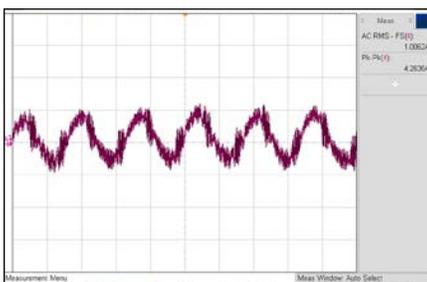
Without SineWave Nexus

Common mode voltage induces dangerous common mode currents throughout the motor and cable resulting in bearing damage, frosting, pitting, and fluting which leads to motor failure.

Common Mode Current (neutral to ground)	Pre Nexus Installation	Post Nexus Installation	Percent Reduction
Peak	2.13A	0.326A	84.7%
RMS	1.0A	0.109A	89.1%

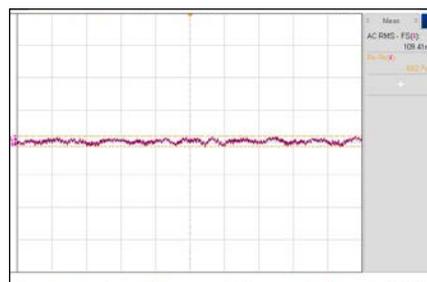
With SineWave Nexus

The dangerous peak voltages and currents are reduced by over 98% and 84%, respectively, with the Nexus installed.
